LITIGATION TECHNICAL SUPPORT AND SERVICES
ROCKY MOUNTAIN ARSENAL
DRAFT FINAL VOLUME I
INVENTORY REPORT
POLYCHLORINATED BIPHENYL (PCB)
INVENTORY

Contract No. DAAA05-89-C-0002
September 1990

EBASCO SERVICES INCORPORATED

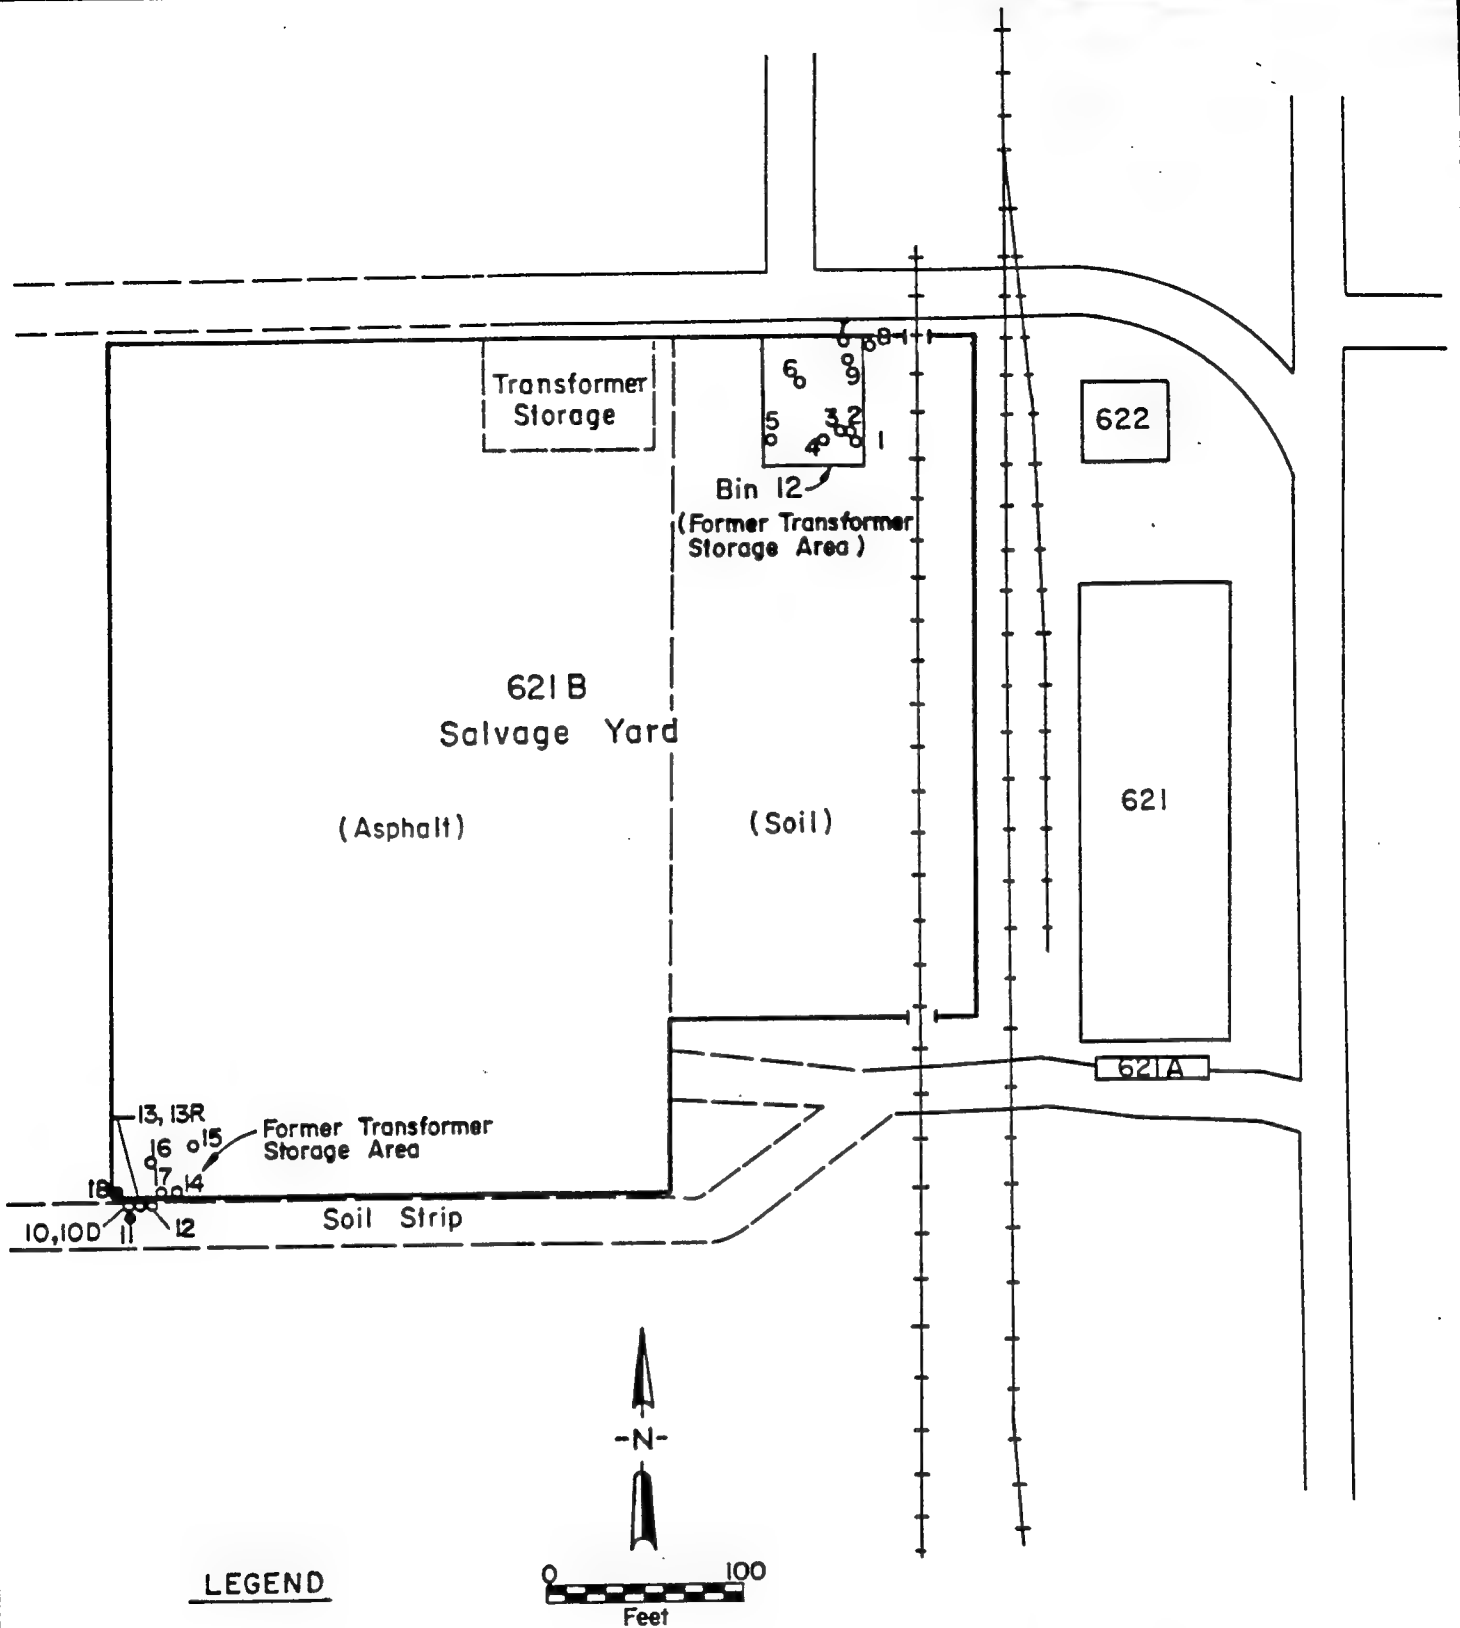
FIGURE	PAGE
2-1 PCB SAMPLE LOCATIONS - 621B, SALVAGE YARD	12

yard. The soil in the southeast corner of this bin is moderately stained. Eight 0 to 6 inch soil samples and one liquid sample of gear oil from a leaking container were taken from this area. A thin strip of stained soil lying immediately south of the southwest corner of the asphalt pad (edge of an old dirt road) was the second location sampled. Five soil samples at depths of 0 to 6 inches were obtained from this location, plus a rinse blank sample of the sampling equipment decon water (water used for decontamination of equipment). The third location sampled is the southwest corner of the asphalt pad where five distinct stained areas on the asphalt surface are visible.

PCBs were found above 50 ppm in the 0 to 6 inch interval of one soil sample from the soil strip south of the asphalt pad, and the 0 to 1 inch interval of one asphalt sample from the southwest corner. Both samples were obtained from the above mentioned former transformer storage locations within the 621B Salvage Yard.

As evidenced from the staining, a thin strip of soil (at one time, the northern edge of an old dirt road) lying immediately south of the southwest corner of the asphalt pad is believed to have served as a drainage receptor for any dielectric fluid or liquids leaking from the transformers previously stored on this portion of the asphalt pad. A concentration of 160 ppm in the 0 to 6 inch interval of Soil Sample (PCB)04621B2, and concentrations ranging from 6.8 to 26 ppm in adjacent soil samples (0 to 6 inch interval) from the immediate area further confirmed the release of PCB-bearing dielectric fluid into this portion of soil south of the asphalt pad.

The relatively low PCB concentrations (1.2 to 27 ppm) detected in soil samples from Bin 12 that accompany the minor staining observed in this soil also confirmed the release of PCB-bearing dielectric fluid from previously stored transformers into the soil of Bin 12; however, concentrations in this area were found to be below the 50 ppm storage and disposal standard. There will be no labelling or marking of equipment in accordance with 40 CFR 761 because equipment containing PCBs in concentrations of 50 ppm to 500 ppm was not found in the Group I buildings.

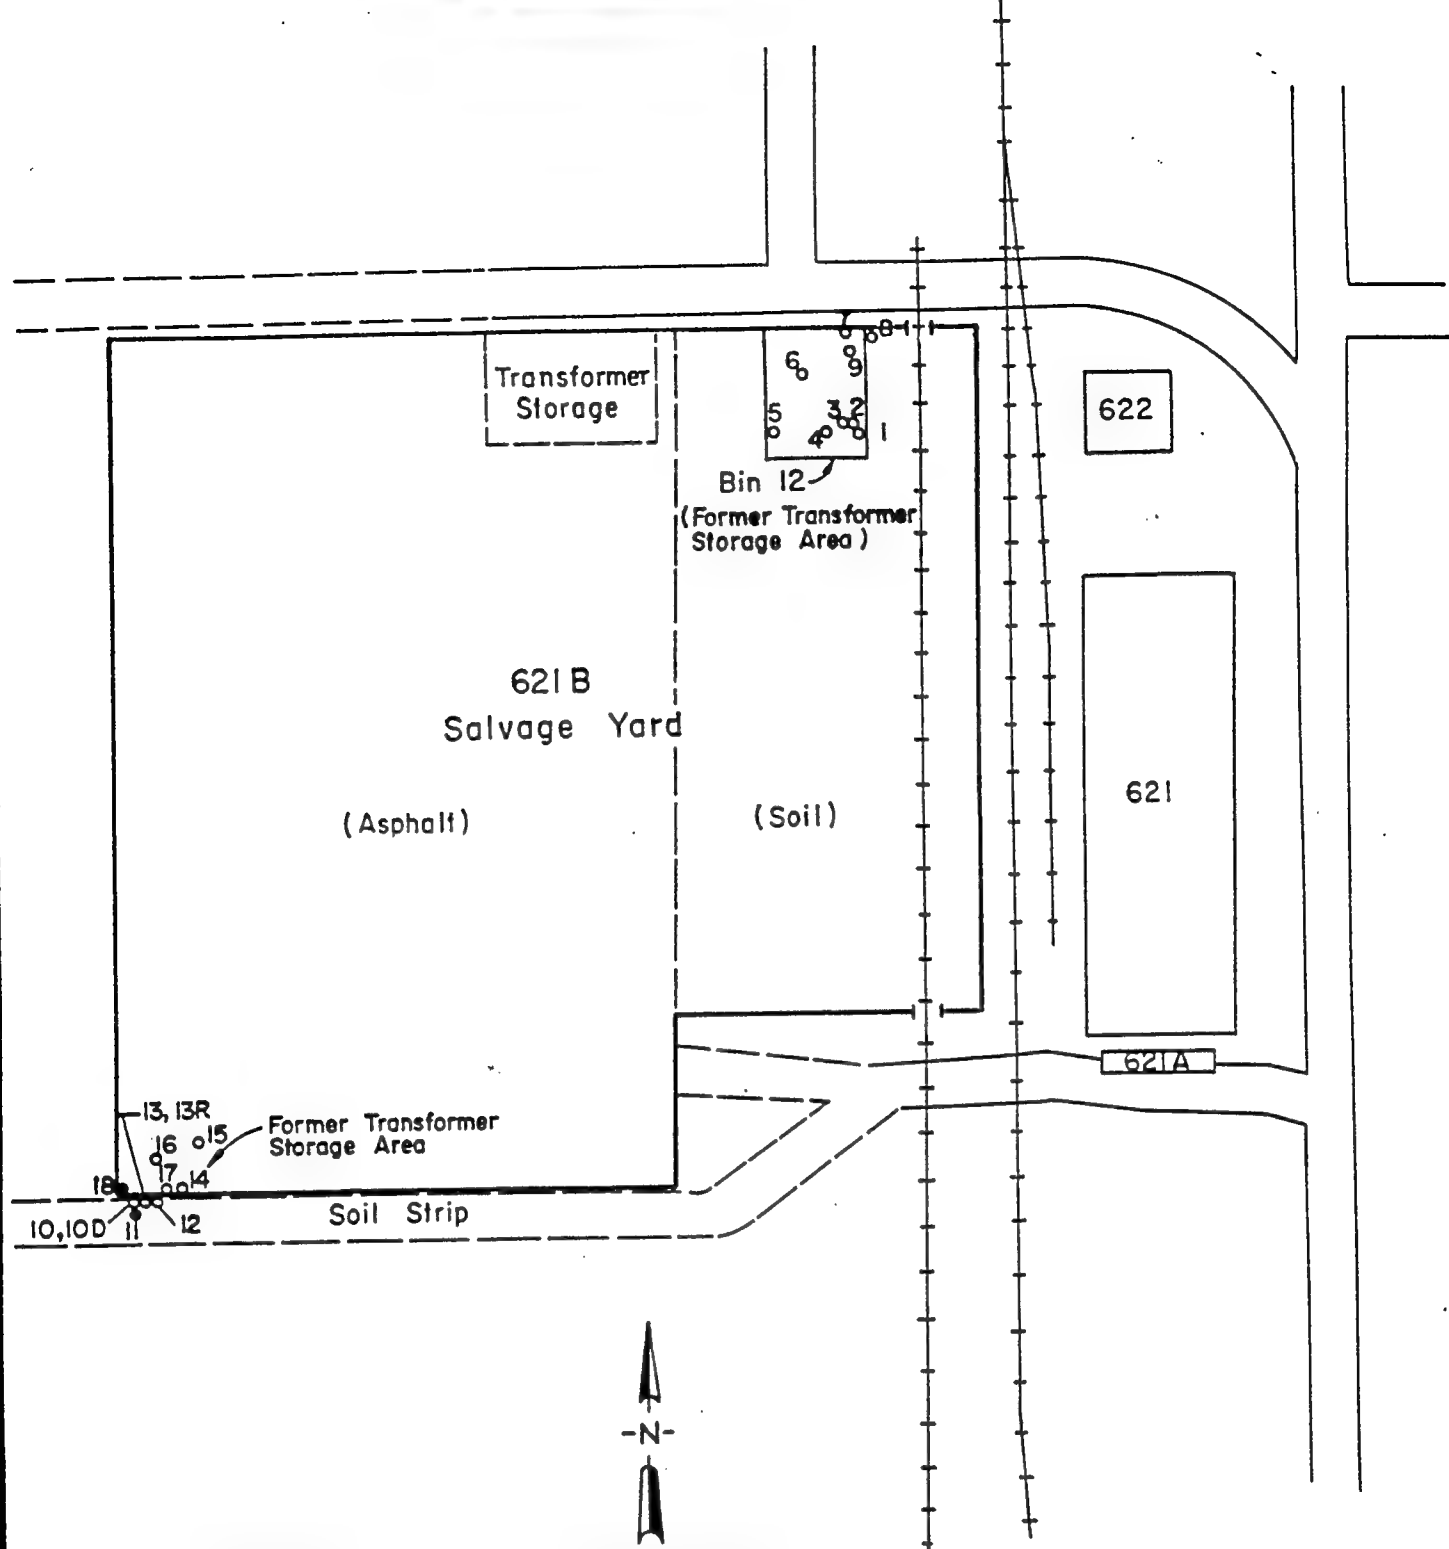
yard. The soil in the southeast corner of this bin is moderately stained. Eight 0 to 6 inch soil samples and one liquid sample of gear oil from a leaking container were taken from this area. A thin strip of stained soil lying immediately south of the southwest corner of the asphalt pad (edge of an old dirt road) was the second location sampled. Five soil samples at depths of 0 to 6 inches were obtained from this location, plus a rinse blank sample of the sampling equipment decon water (water used for decontamination of equipment). The third location sampled is the southwest corner of the asphalt pad where five distinct stained areas on the asphalt surface are visible.

PCBs were found above 50 ppm in the 0 to 6 inch interval of one soil sample from the soil strip south of the asphalt pad, and the 0 to 1 inch interval of one asphalt sample from the southwest corner. Both samples were obtained from the above mentioned former transformer storage locations within the 621B Salvage Yard.

As evidenced from the staining, a thin strip of soil (at one time, the northern edge of an old dirt road) lying immediately south of the southwest corner of the asphalt pad is believed to have served as a drainage receptor for any dielectric fluid or liquids leaking from the transformers previously stored on this portion of the asphalt pad. A concentration of 160 ppm in the 0 to 6 inch interval of Soil Sample (PCB)04621B2, and concentrations ranging from 6.8 to 26 ppm in adjacent soil samples (0 to 6 inch interval) from the immediate area further confirmed the release of PCB-bearing dielectric fluid into this portion of soil south of the asphalt pad.

The relatively low PCB concentrations (1.2 to 27 ppm) detected in soil samples from Bin 12 that accompany the minor staining observed in this soil also confirmed the release of PCB-bearing dielectric fluid from previously stored transformers into the soil of Bin 12; however, concentrations in this area were found to be below the 50 ppm storage and disposal standard. There will be no labelling or marking of equipment in accordance with 40 CFR 761 because equipment containing PCBs in concentrations of 50 ppm to 500 ppm was not found in the Group I buildings.
